WEBBING WEAR

The following tables are relevant to TRUBLUE XL, QUICKjump XL, zipSTOP IR and FlightLine zebra webbing only.

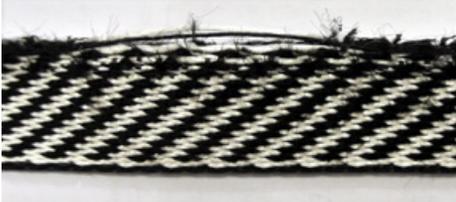
REPLACEMENT TABLE	
Wear Type	Point of Replacement
EDGE WEAR

<p>The webbing MUST be removed from service when at least 2.5 cm of the side thread can be pulled away from the webbing. Webbing should be removed when the webbing shows at least Stage 3 side wear shown in Table 2.</p>
FACE WEAR
